Manhole Inspection Summary

Manhole # S27G__002MH

Location Address: **10 Scheoder St**

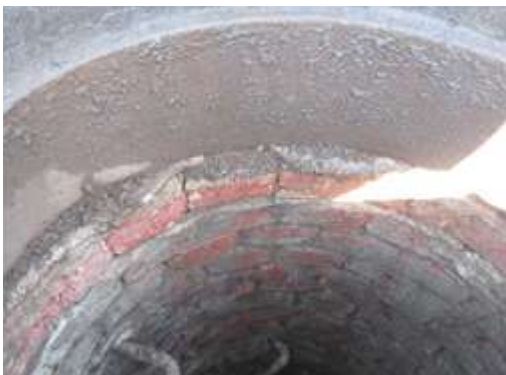
Defect 5

Condition: ☐ Sound ☐ Cracked ☒ **Leaks**

offset 1 inch infiltration from lid frame connect, frame leaks

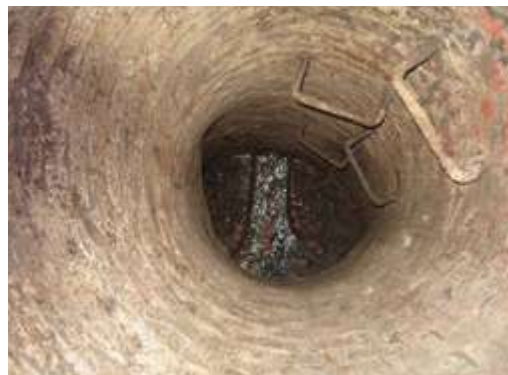
Defect 3

Infiltration: ☐ None ☐ Joint ☐ Cracks ☐ Mortar ☐ Roots ☒ **Wall**

chimney infiltration wall

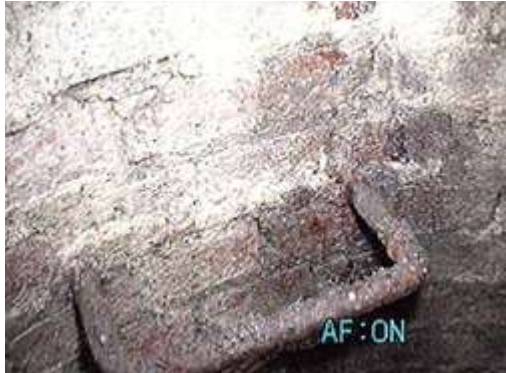
Defect 4

Infiltration: ☐ None ☐ Joint ☐ Cracks ☐ Mortar ☐ Roots ☒ **Wall**

Count: **7** Missing: **0** ☒ **Corroded**

infiltration corbel, steps corroded

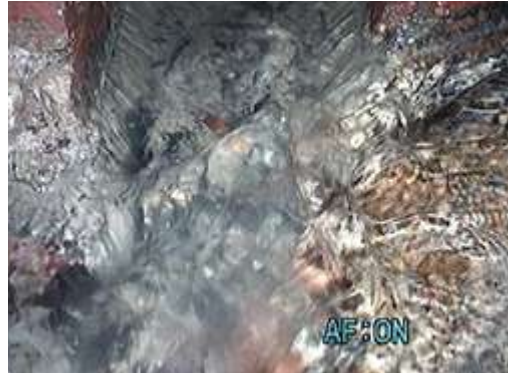
Defect 2

Condition: ☐ Sound ☐ Cracked ☐ Root Intrusion ☐ Deteriorated ☐ Leaks ☒ **Debris**

debris in channel

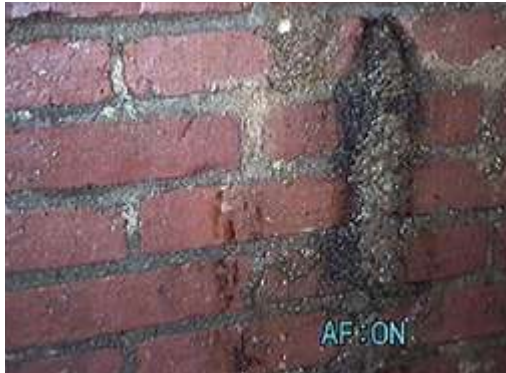
Defect 1

Condition: ☐ Sound ☐ Cracked ☐ Root Intrusion ☐ Loose Brick ☒ **Deteriorated**

Infiltration: ☐ None ☐ Joint ☐ Cracks ☒ **Mortar** ☐ Roots ☒ **Wall**

barrel infiltration mortar, barrel infiltration wall, barrel infiltration mortar

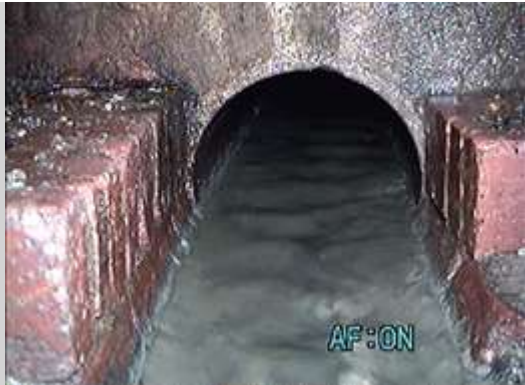
6 O'Clock Inflow

Infiltration: **Evidence** Pipe Seal Cond: **Unknown**

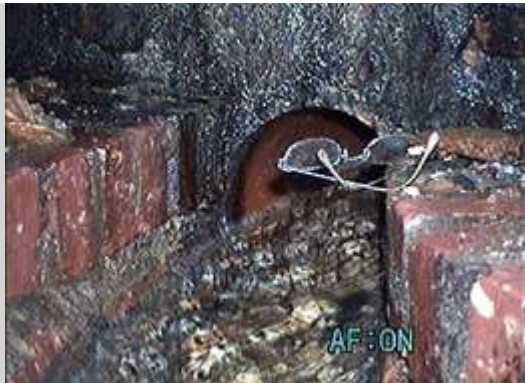
7 O'Clock Inflow

Deposits: ☐ None ☐ Mud ☐ Sludge ☒ **Debris** ☐ Grease

Silt Depth: **2** (in.) Deposits Extent: **Medium**
